REPORT NOS. DOT-TSC-NHTSA-79-30

✓
✓
DETERMINATION OF TIRE QUALITY.
FROM NONDESTRUCTIVE INSPECTION

U.S. DEPARTMENT OF TRANSPORTATION
RESEARCH AND SPECIAL PROGRAMS ADMINISTRATION
Transportation Systems Center
3 Cambridge MA 02142

NOVEMBER 1979
FINAL REPORT

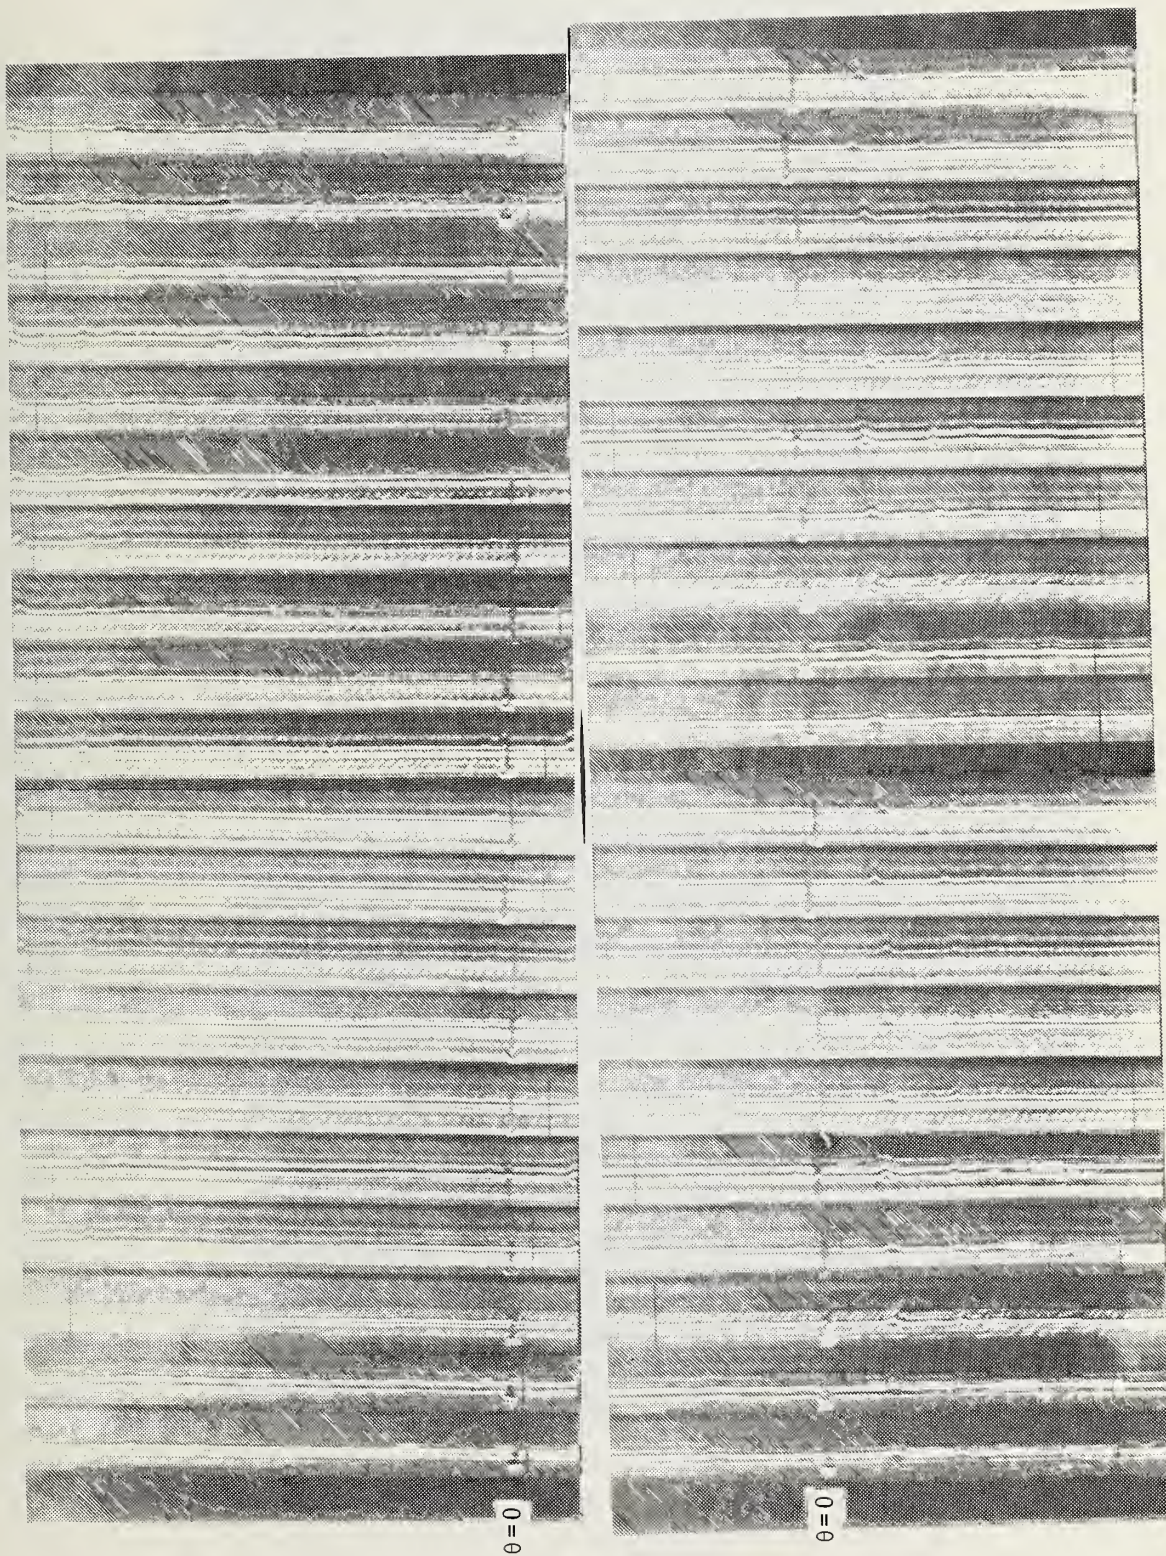
FIGURE A-4 EXAMPLE OF REGISTRATION ERROR

In some cases it is desirable to superimpose traces as in "before and after" data on the same tire. It is therefore necessary to have the $\Theta=0$ location always at the top of the display. When this does not occur, it is called a registration error. Figure 4 shows two examples of this condition on the same tire.

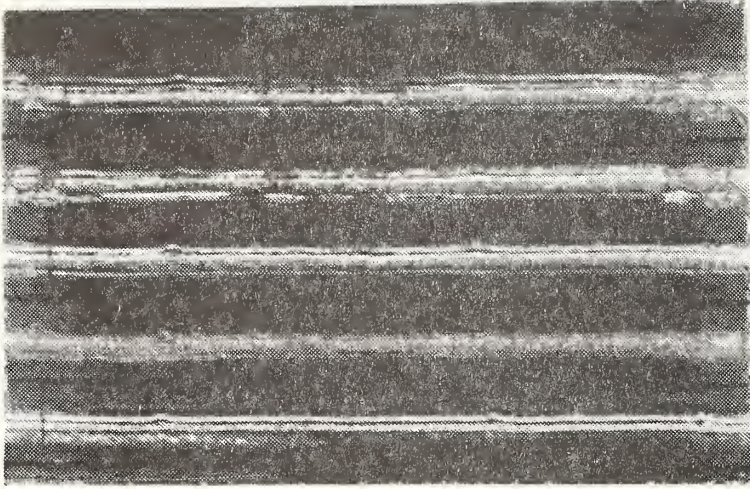
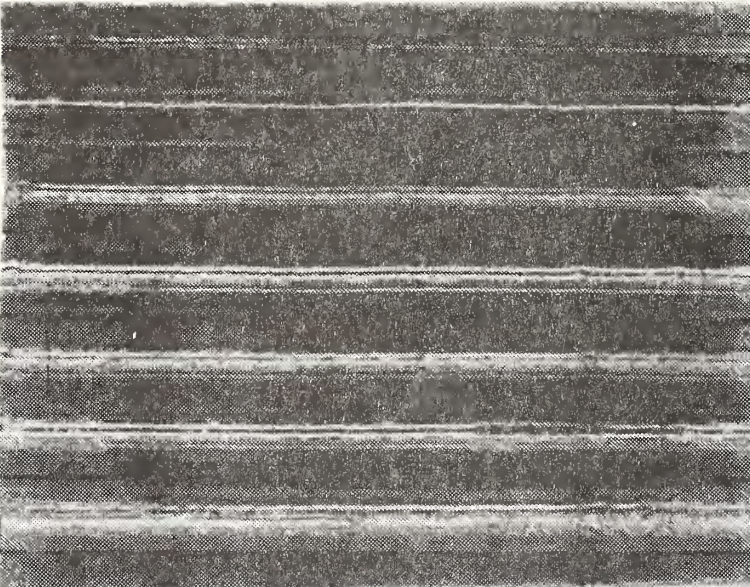
FIGURE A-5 TURN-UP AREA

Abrupt brightness change (Figure A-5). It is caused by overlapping or separation of material near the tire beads.

SEVERE TURNUP
MODULATION

LITTLE OR NO
TURNUP MODULATION

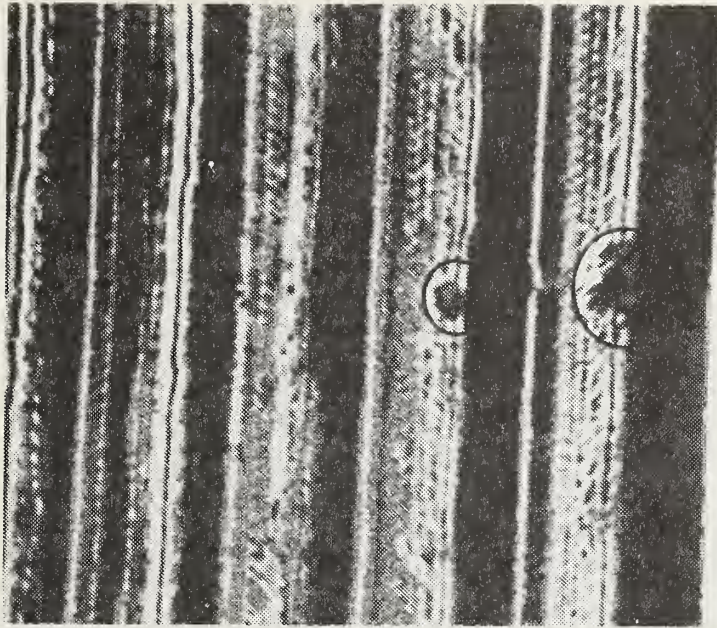
FIGURE A-6. EXAMPLE OF INCLUSION

A lack of reflection from several depths and generally present in more than one channel (see Figure A-6), not to be confused with a single trace separation or fading of a trace. It is caused by a hole or foreign material in the tire structure.

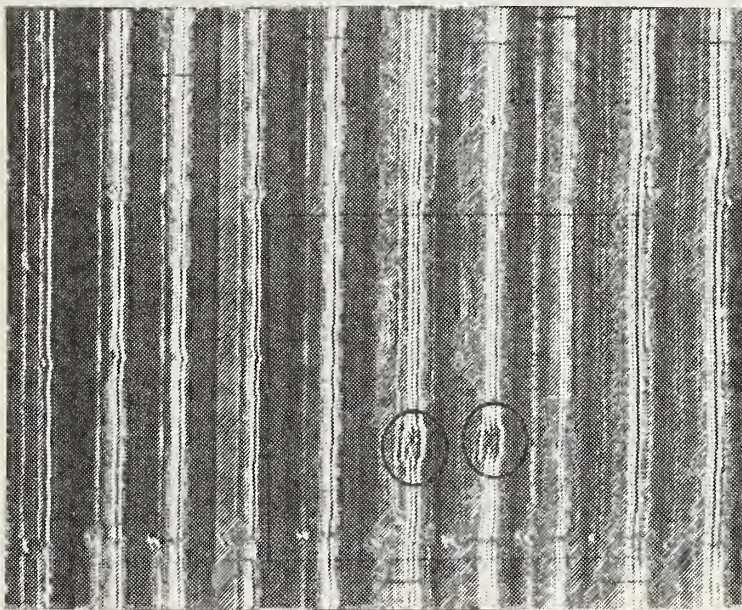
FIGURE A-7 EXAMPLE OF SINGULARITY/SHADOW

A bright spot adjacent to a shadow (Figure A-7). It is caused by a separation or other discontinuity.

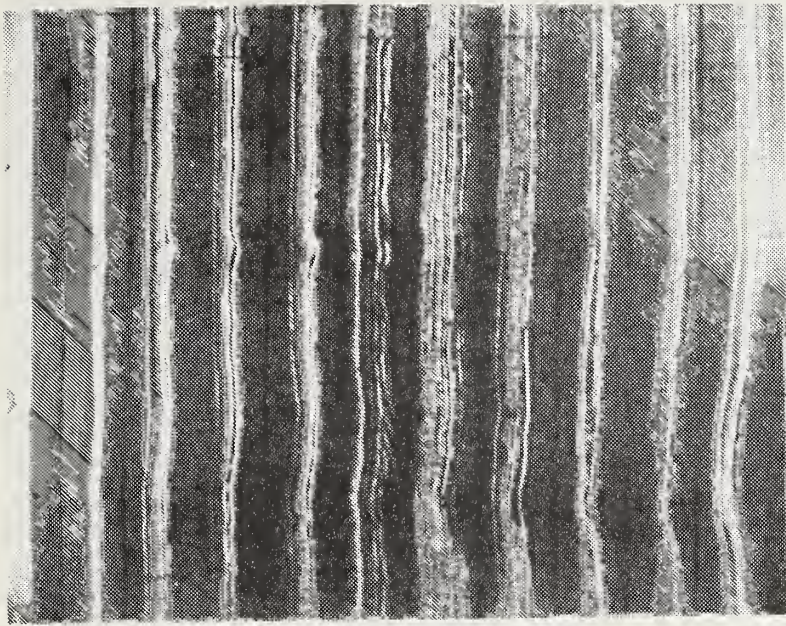
FIGURE A-8. RADIAL RUNOUT

Skewed or wavy trace (Figure A-8). Caused by "out of roundness"; the resulting "high spot" passes closer to transducer #10 than the remainder of the tire.

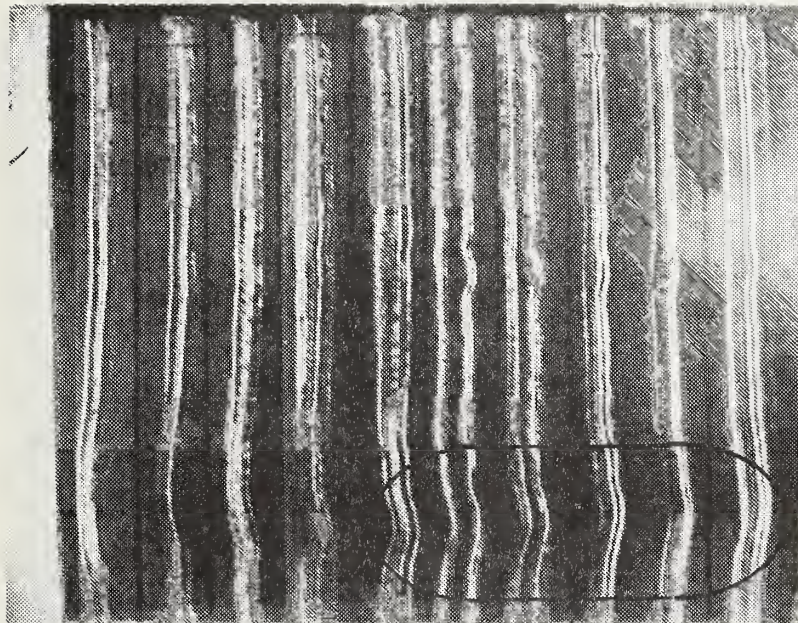
FIGURE A-9. LATERAL RUNOUT

Wavy trace (Figure A-9). Caused by a change in tire width.

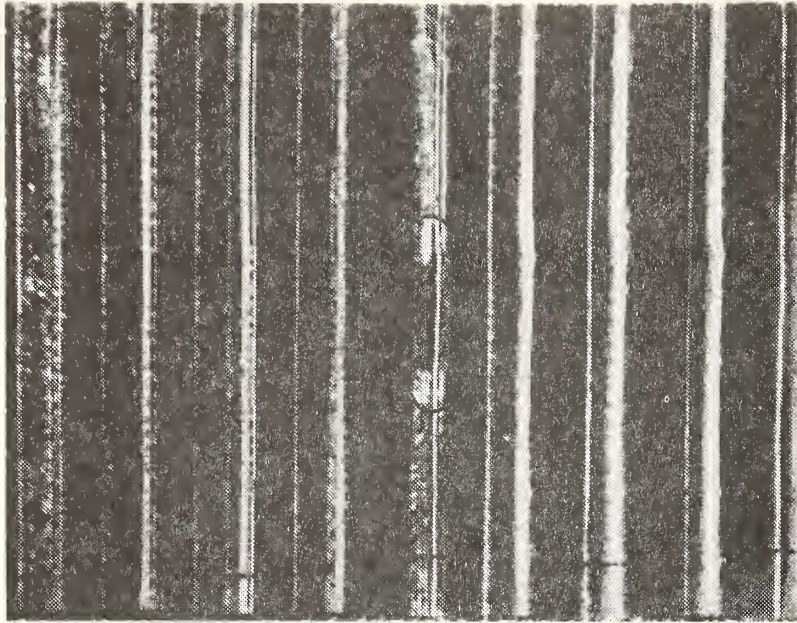
FIGURE A-10. INTENSITY CHANGE

Abrupt brightness change (Figure A-10). Caused by a change of material thickness.

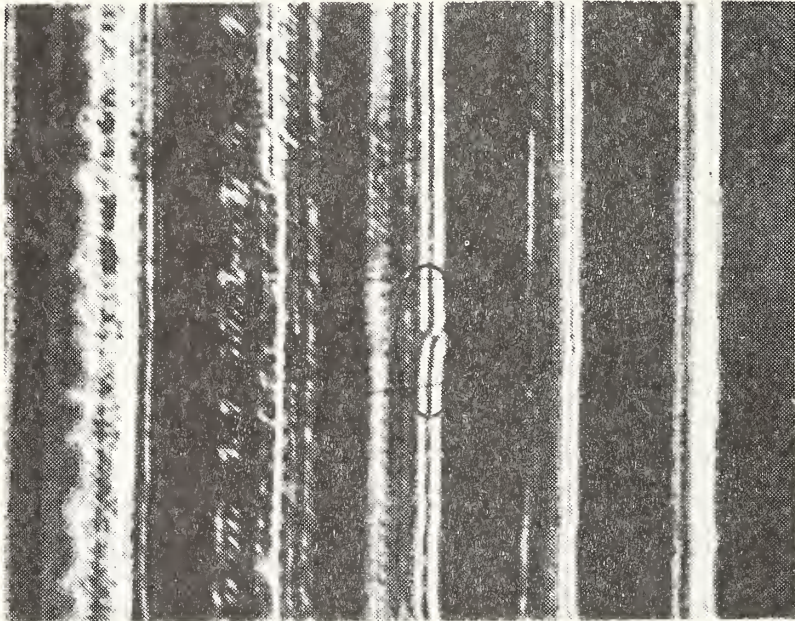
FIGURE A-11. TRACE DISCONTINUITY

Interruption of a trace (Figure A-11), not to be confused with an inclusion which is usually indicated in more than one channel. It is caused by abnormal displacement of material.

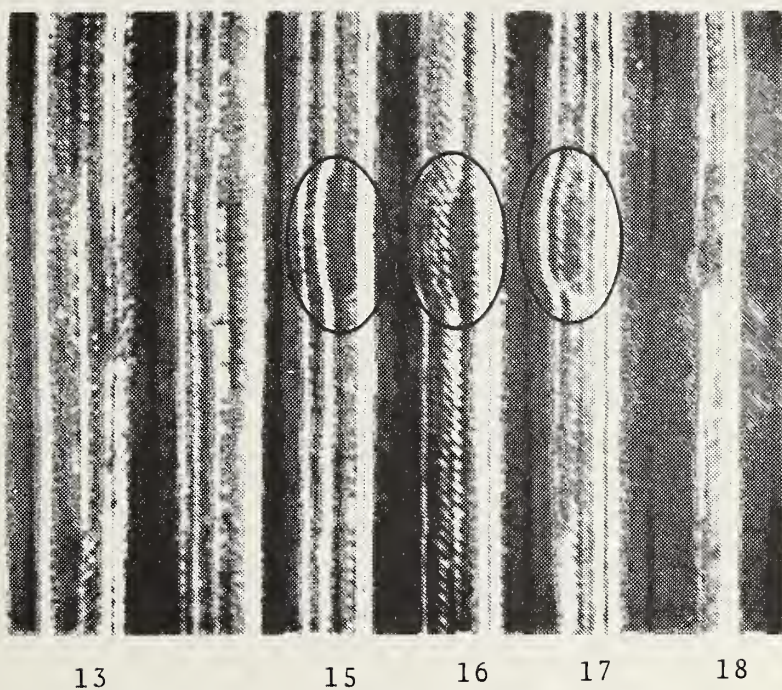
FIGURE A-12. SHAPE DISCONTINUITY

Abrupt change of shape of trace (Figure A-12). It is caused by excess of material or distorted ply structure.
